# NBS TECHNICAL NOTE 837

## Barrier Penetration Tests

Sixteen structural barrier panels were tested to determine their resistance to forcible penetration through the use of readily available tooling. Thirteen of these represented experimental techniques to reinforce an existing structural barrier of low penetration resistance; the other three were designs which would be most appropriate to consider as replacement barriers. Minimum man-passable sized openings were made in the barriers in working times which averaged 7.85 minutes and ranged from 1.52 to 25.56 minutes. One of the replacement and two of the reinforcing designs showed superior cost-effectiveness.

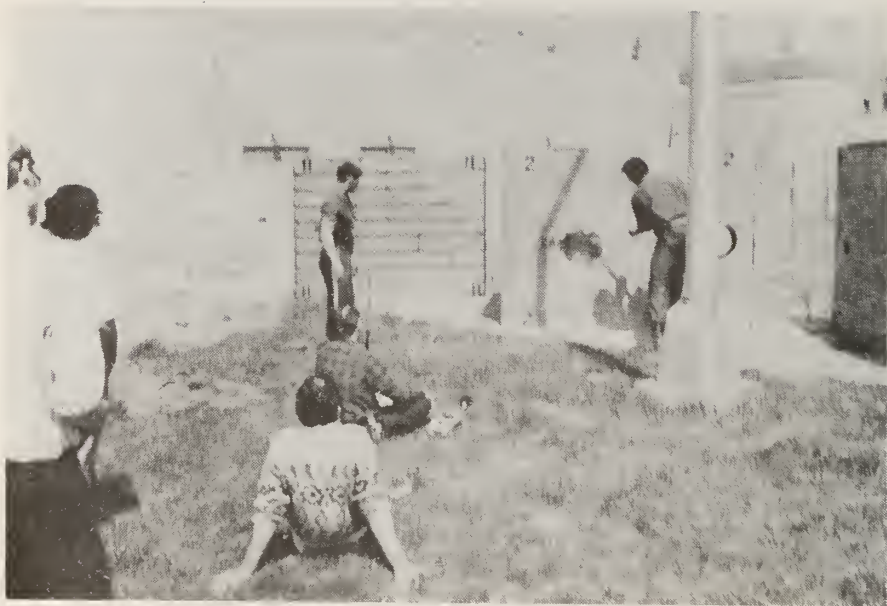
Figure 14. Attack 2A. Exterior, Attack in Process

Thereafter, the opening was enlarged by using the cutting maul and sledgehammer in alternating series of blows as in figure 14. The final 96 square inch opening was nearly circular in shape and appears in figure 15. It required 725 blows with the 10-pound sledgehammer and 300 blows with the 6-pound cutting maul. The total working time was 25.56 minutes giving an average time of 1.575 seconds per blow. The elapsed time was 58.75 minutes. The penetration was accomplished by a fresh two-man team of Marines who were in excellent physical condition and who were motivated to try to better penetration times which had been recorded in prior tests involving Army and Navy personnel. It is believed that a five-man team of intruders would be necessary in order to reduce the elapsed time to a value just slightly greater than the working time for an attack of this type and duration.

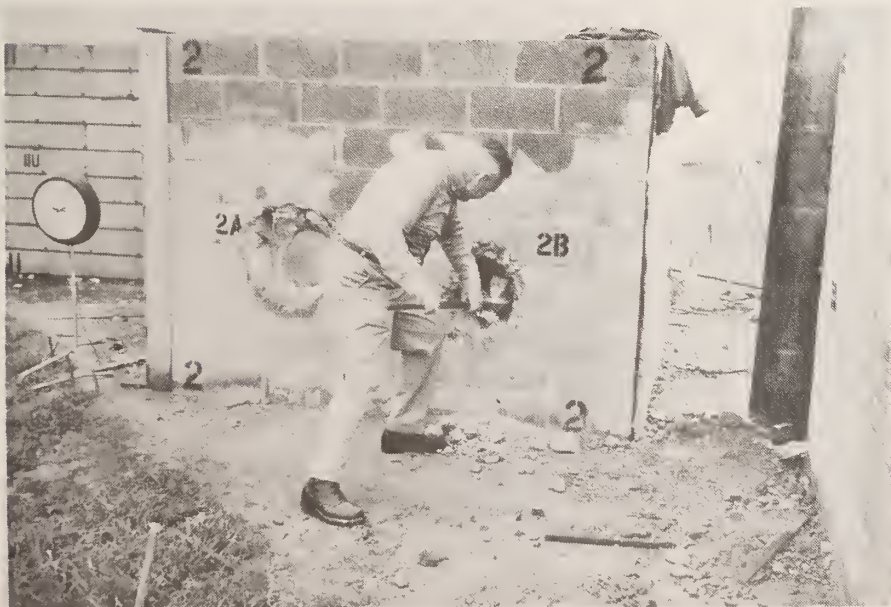
Figure 22. Enlarged Opening with  
26-lb. Bar ; Test 2B

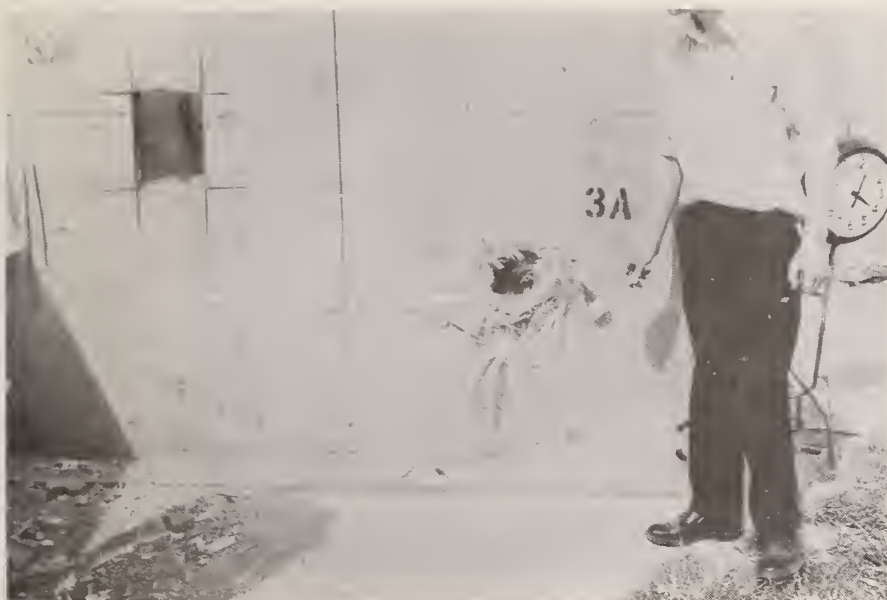
Figure 25. Opening Produced by  
6-lb. Chopping Maul;  
Test 3A

With the 6-pound chopping maul, 80 blows in 2.11 minutes working time produced an opening approximately 6" X 6" in size through the plywood, polyurethane, expanded metal and the outer layer of the concrete block, as shown in figure 25. Multiple sweeps of the acoustical and vibrational disturbances that were produced are shown in figures 26 and 27, respectively. Then, using the forked end of the 50-pound battering ram in a two-man attack for 16 blows, the concrete block was completely broken through and the face of the opening enlarged to 8" X 8". With 27 more blows from the maul and 22 more from the ram, the opening was enlarged to 14" X 7-1/2". Then a few light blows with the 10-pound sledgehammer flattened the broken, expanded metal against the sides of the opening to provide the necessary area (see fig. 28). The total working time was 3.84 minutes and the elapsed time 5.17 minutes.

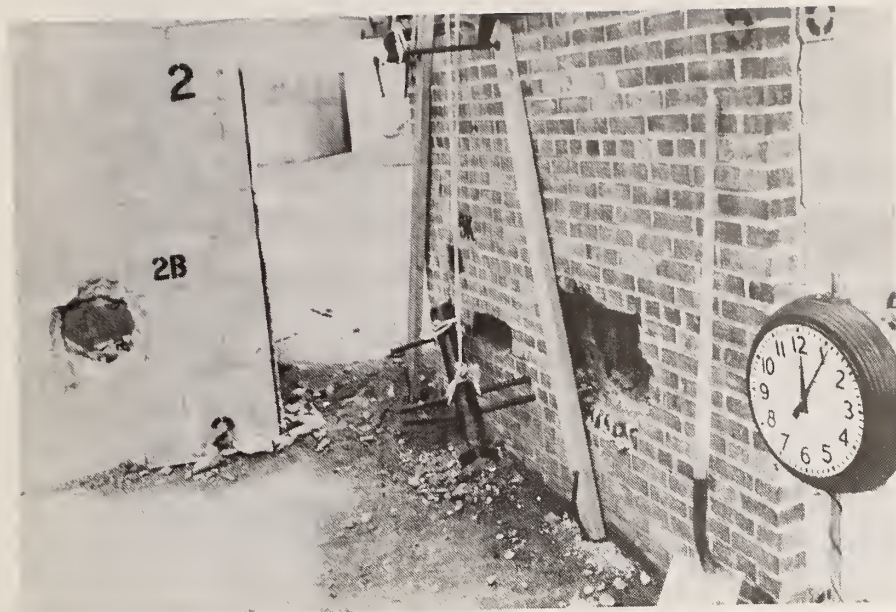
Figure 40. Test 5K. Battering Ram  
Suspended from A-Frame

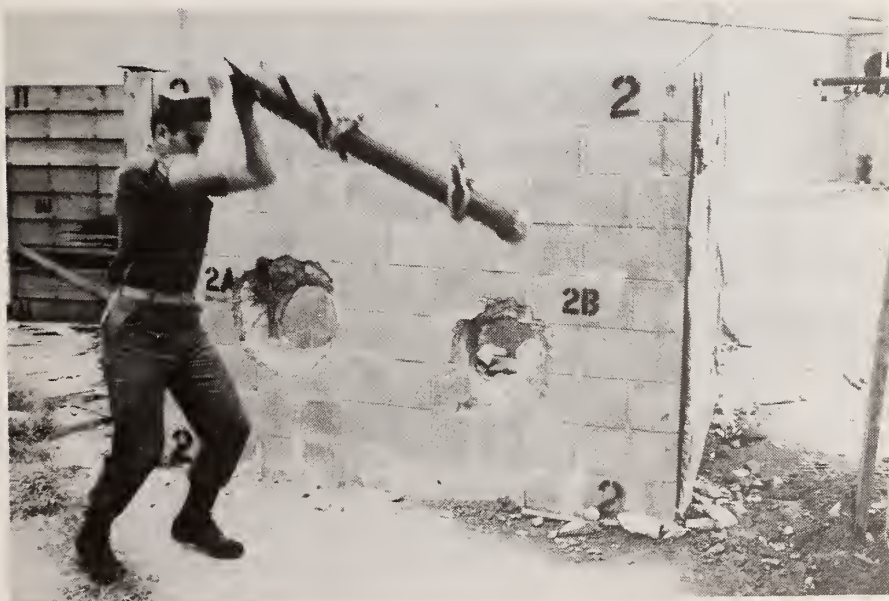
Figure 41. Test 5K. Single Man Using Suspended  
Battering Ram, Raising Center of  
Gravity 24"

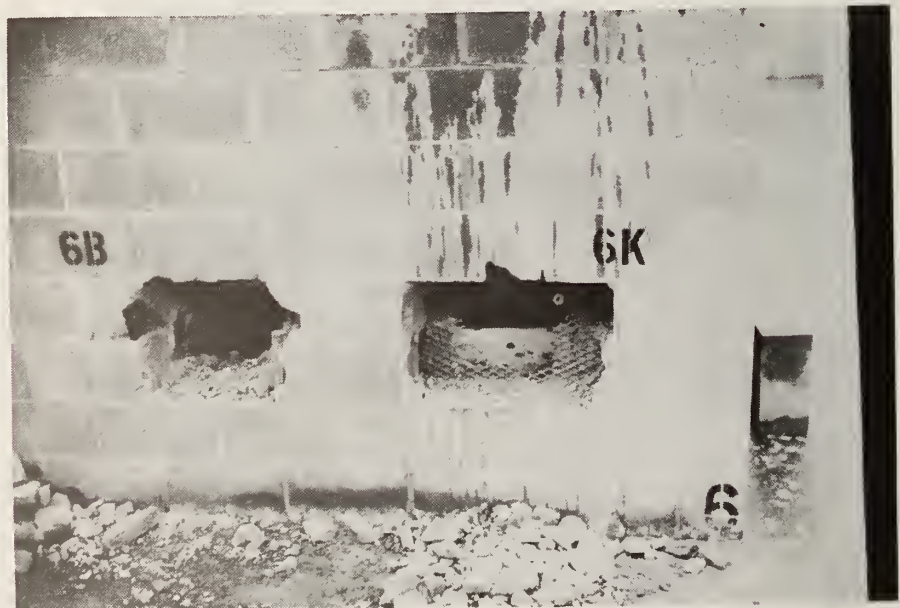
Figure 51. Opening Produced by 50-lb.  
Battering Ram and No. 14  
Bolt Cutters; Test 6K

The 50-pound battering ram was supported by its handles by two men and was swung for 155 blows in 3.17 minutes working time to produce an opening with external dimensions of approximately 16" X 24". Then, No. 14 bolt cutters were used to cut the expanded metal. This required 1.74 minutes for a total working time of 4.91 minutes and 6.40 minutes of elapsed time and produced a clear opening of 10" X 12" as shown in figure 51.

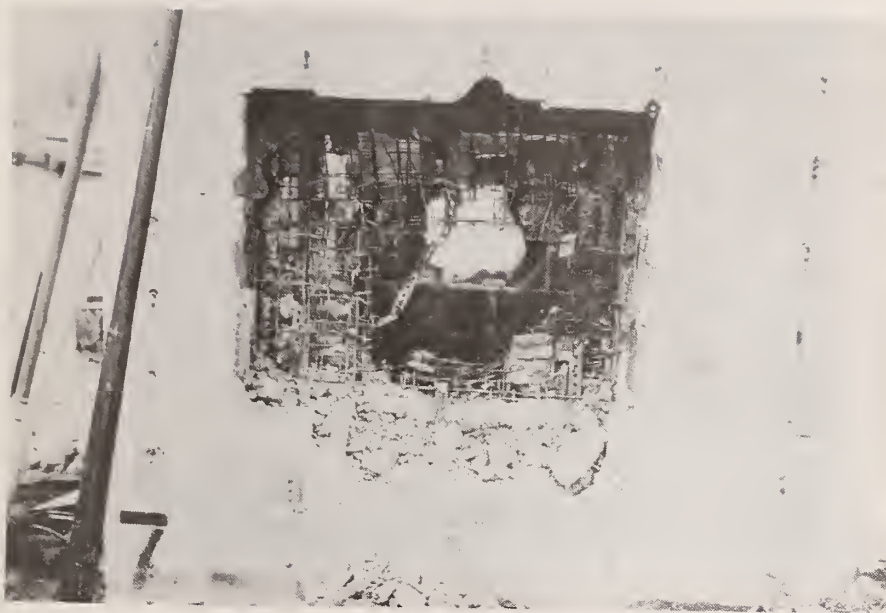
Figure 55. Test 7A with Ferro-cement  
Reinforcing Wires Exposed

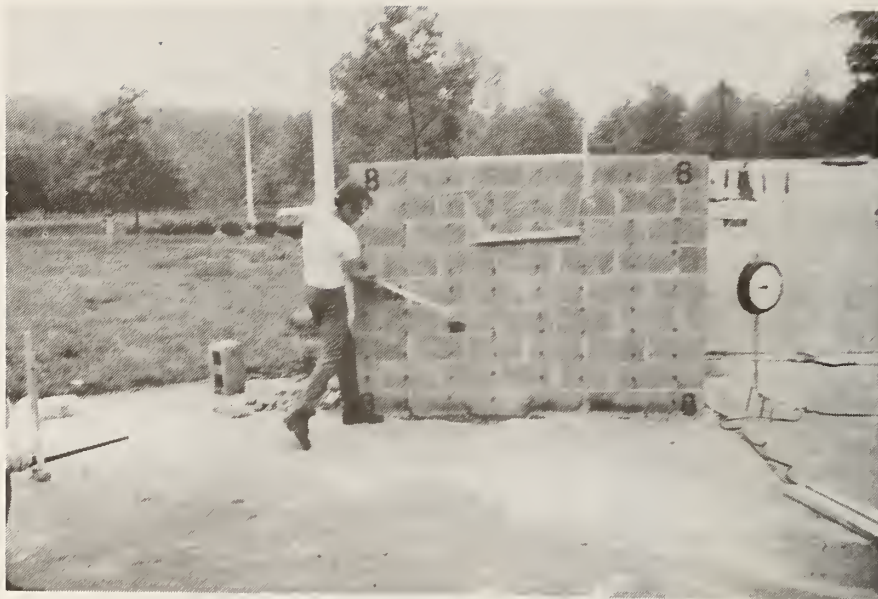
Figure 60. Test 8A, Beginning of Attack

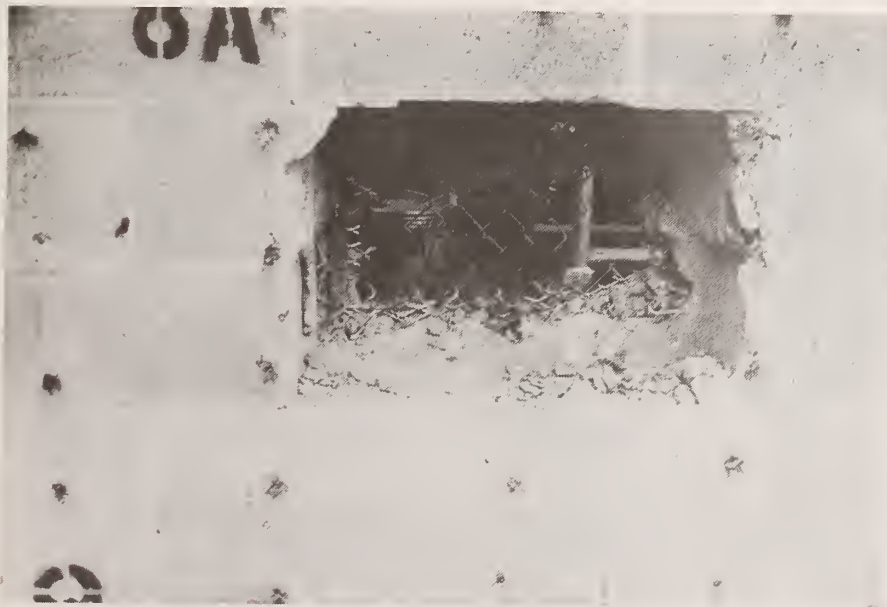
Figure 63. Opening Produced in Test 8A

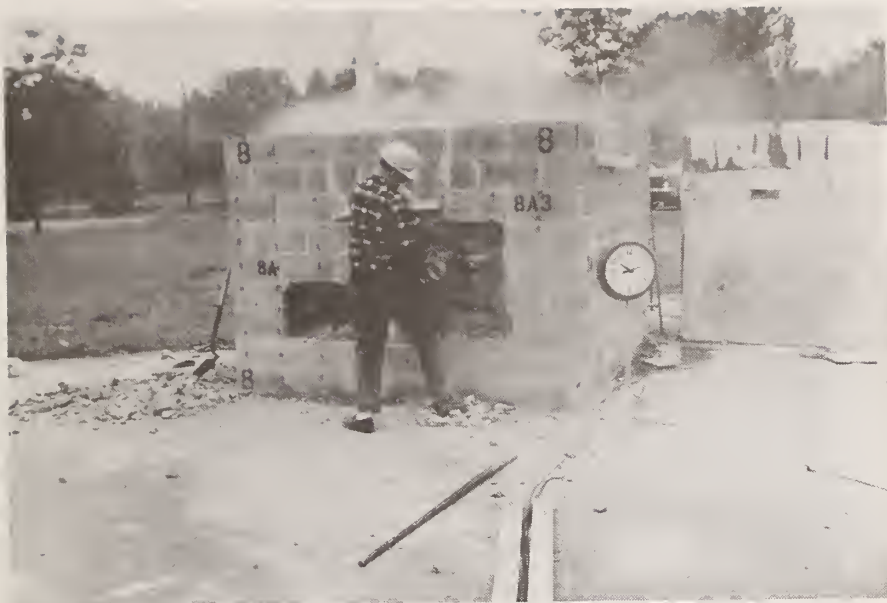
Figure 66. Test 8A3, Abrasive Wheel Saw

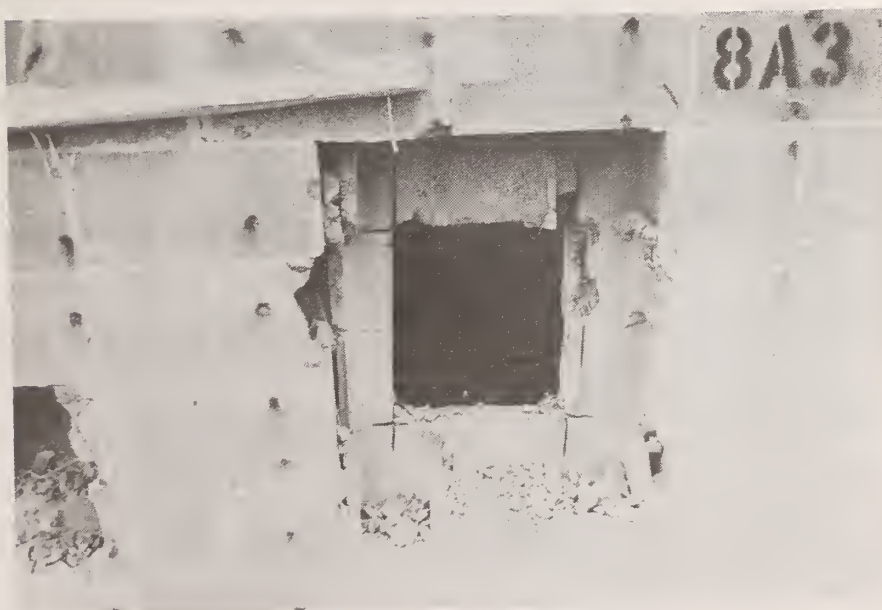
Figure 67. Opening Produced by 14"  
Abrasive Wheel Saw; Test 8A3

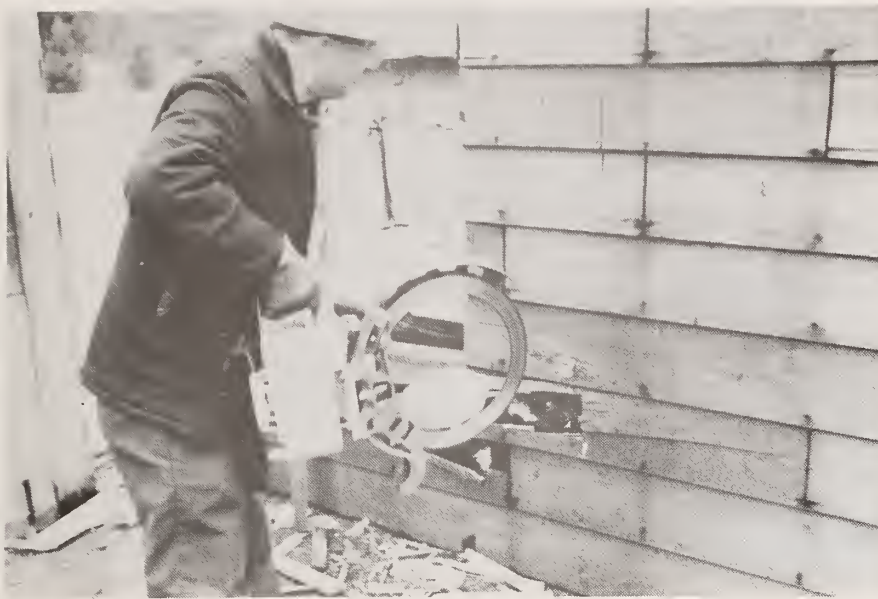
Figure 71. Panel 9. Hubless Saw Attack;  
Test 9M

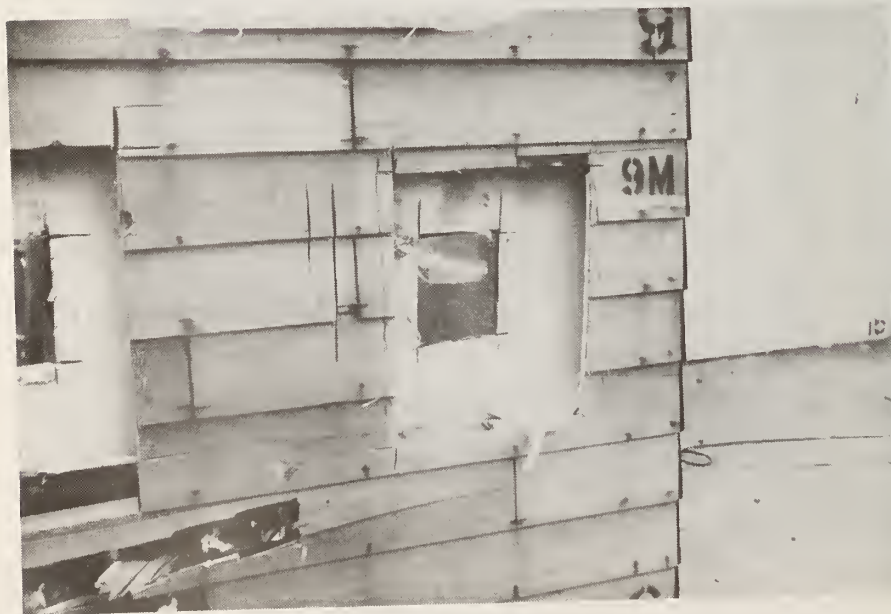
Figure 74. Test 9M. Completed Opening

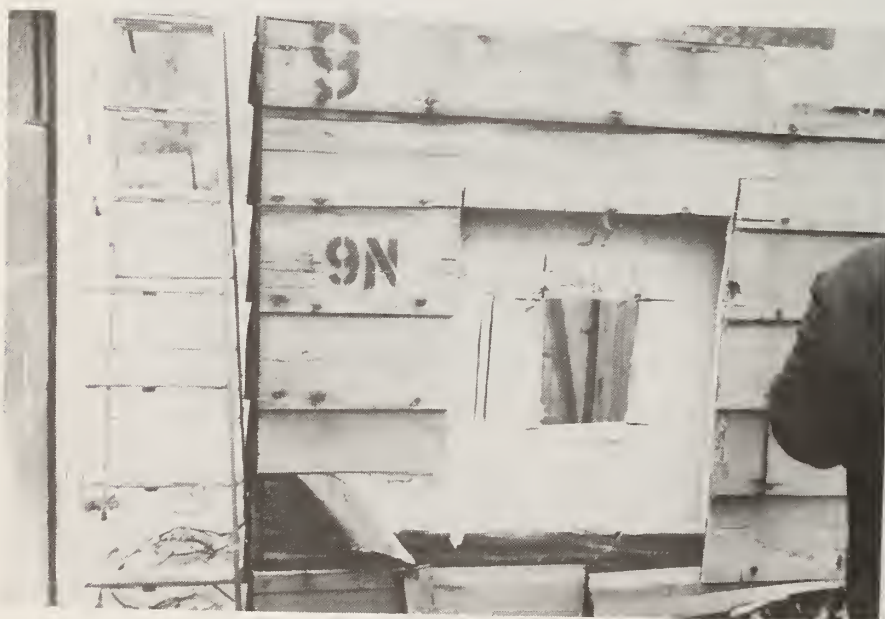
Figure 80. Test 9N. Completed Opening

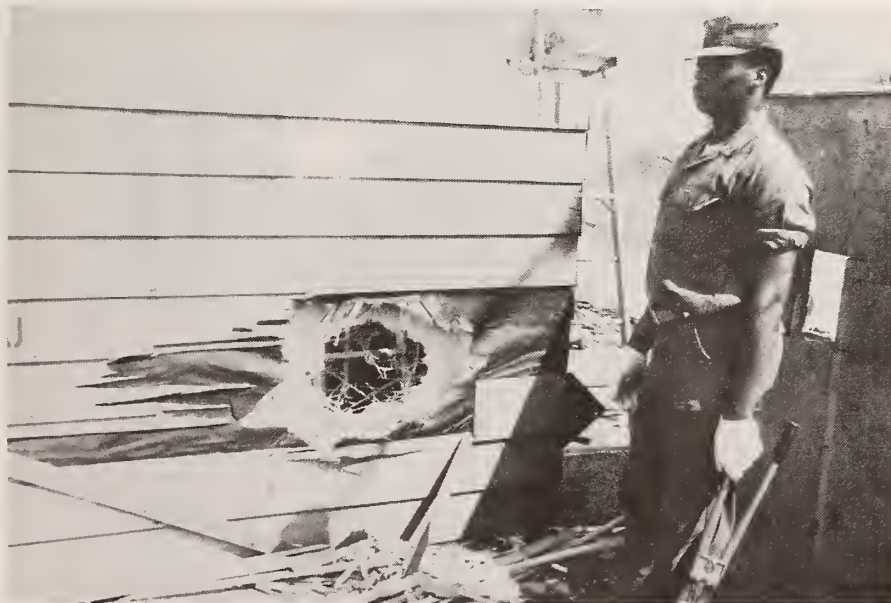
Figure 89. Test 11U. Ferro-cement Reinforcing  
Wire Exposed

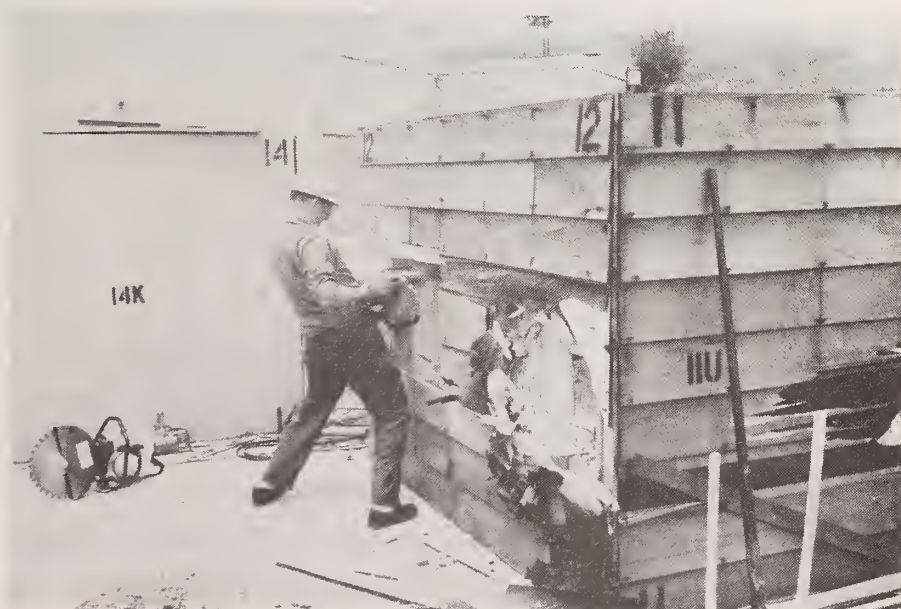
Figure 102. Cutting with Hubless Saw; Test 12

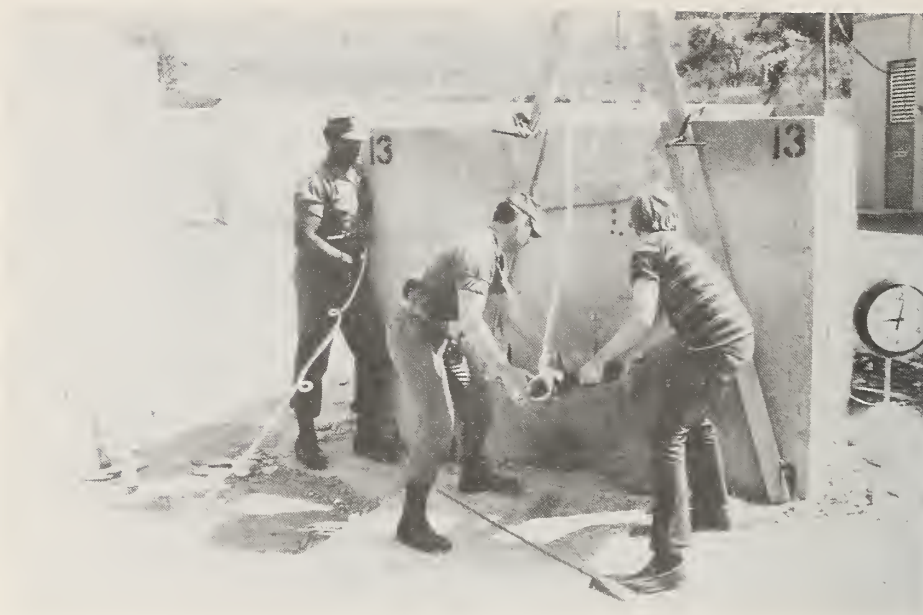
Figure 123. Test 13K. Two-man Operation  
of Suspended Battering Ram

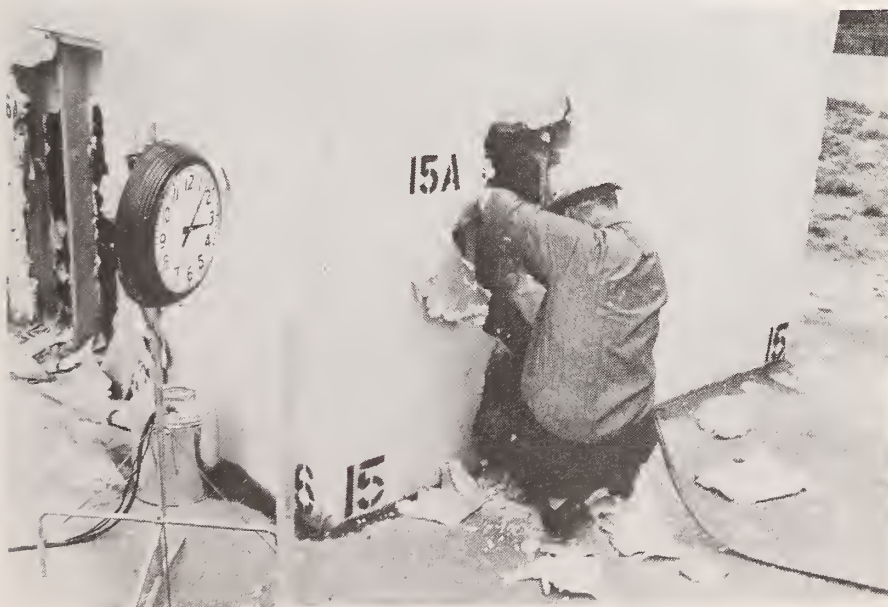
Figure 134. Test 15A. Cutting Steel Plate

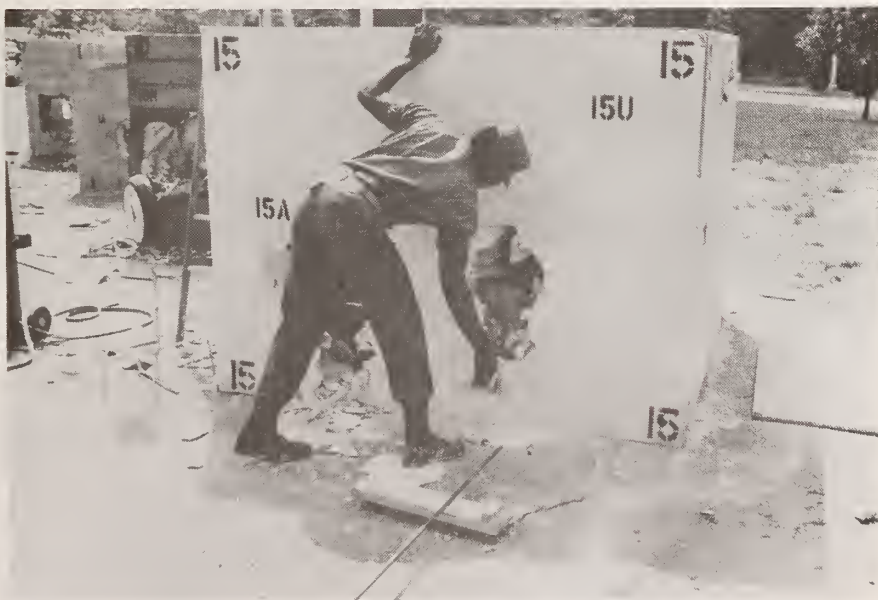
Figure 140. Test 15U. Opening Produced by Kicking Out Plasterboard

As shown in figures 139 and 140, the plasterboard was kicked and cleared out of the target area in 0.24 minute. Then, figure 141, the burning bar was ignited with the oxyacetylene torch and the steel lining was cut out, figure 142, leaving an opening with dimensions of approximately 12"X 14" as shown in figure 143.

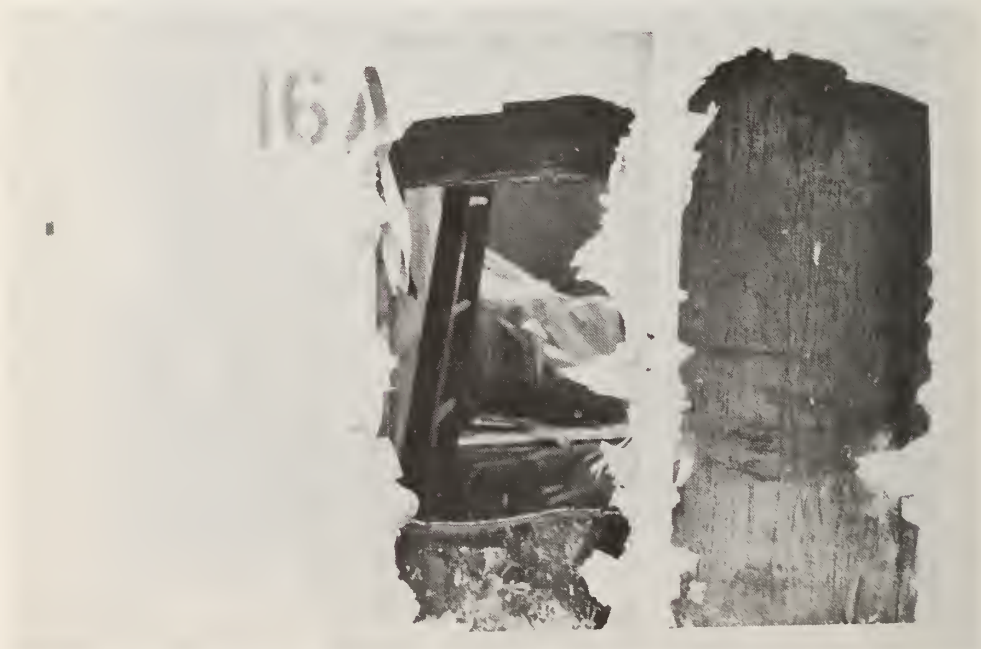
Figure 149. Test 16A. Final Opening

The final opening is shown in figure 149. It took 6.15 minutes working time and 7.63 minutes elapsed time to complete.

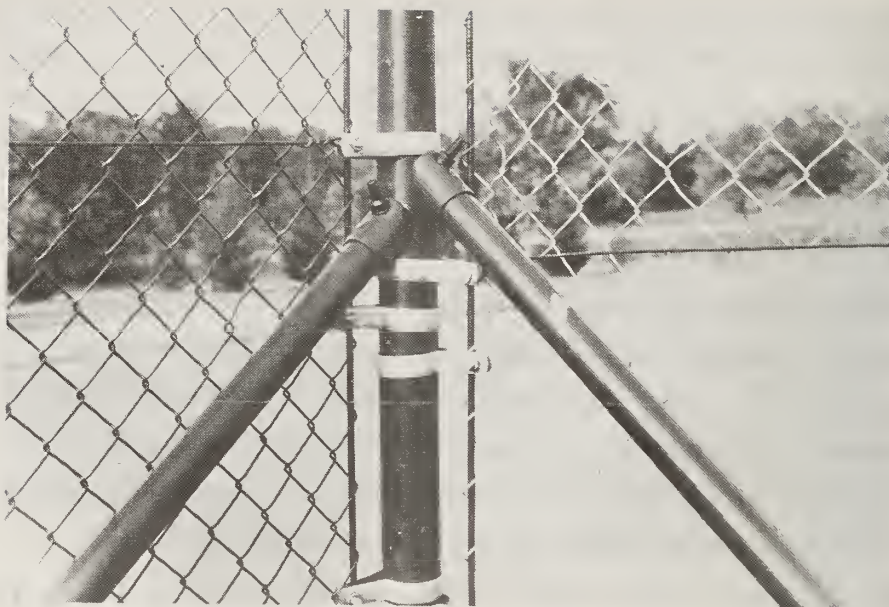
Figure 155. Fencing Using American Fittings  
To Attach Tensions Bars to Poles

enclosure, but a short three-coil pyramid of concertina wire was set up on the inside of one of the metric fence sections and held in place with wire ties to garden type steel fence posts. The metric portion of the fence was constructed by following to the greatest extent possible the rather limited instructions which were supplied by the manufacturer. Where these were found lacking, improvisation was necessary. In particular, American-made fittings were used to attach the tension bars to the poles, as shown in figure 155.

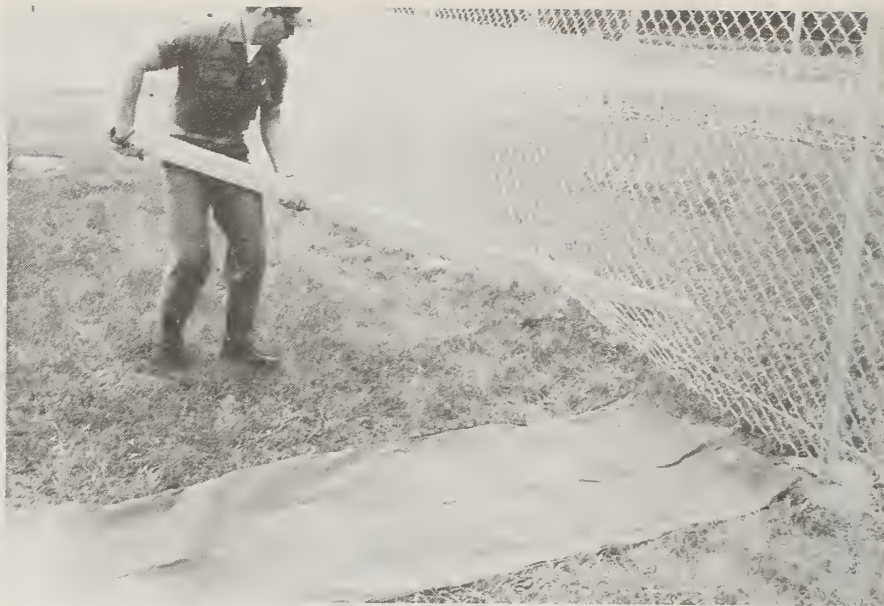
Figure 157. Fence Lifted 12" Using 2" X 4"  
Timber as Lever; Test F1

Despite the 3/8" messenger cable at the bottom of the fence, it could be lifted 12" using the 2" X 4" timber as a lever as shown in figure 157. It took 0.10 minute to lift and one man to crawl under.

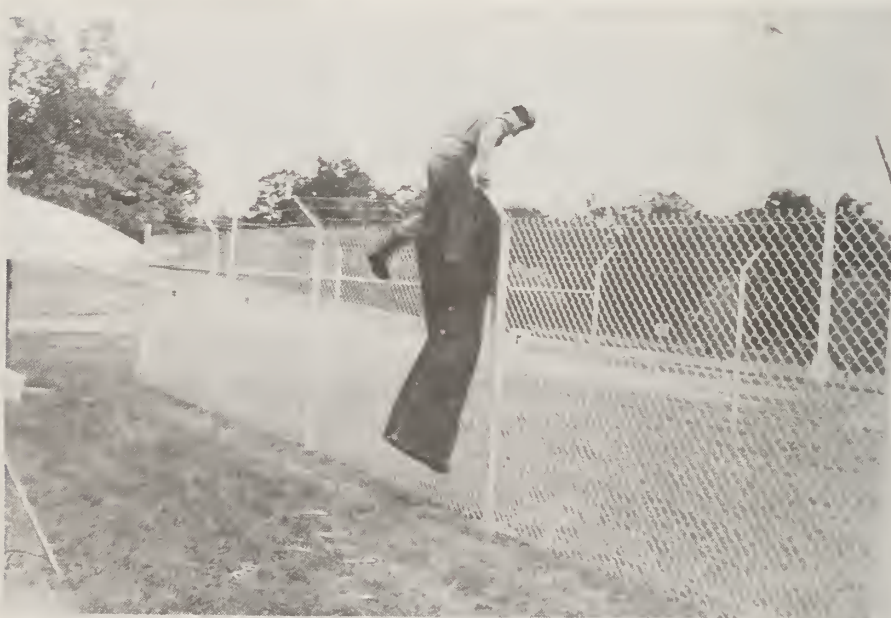
Figure 158. Climb Over Fence Using Tarpaulin  
as Protection against Barbed Wire;  
Test F1

A climb over the top was made in 0.15 minute using a folded tarpaulin for protection against the barbed wire as shown in figure 158. That time included throwing the tarpaulin in place.

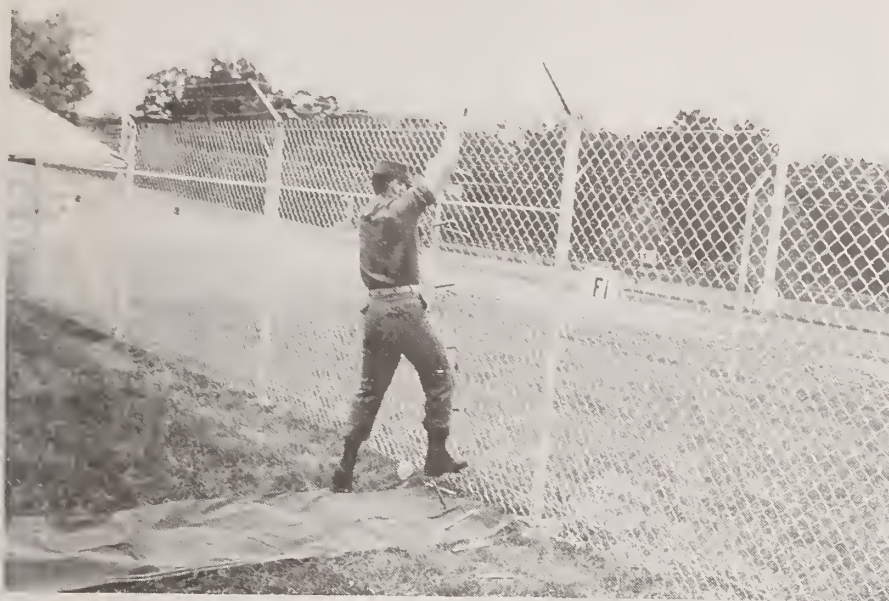
Figure 159. Climb Over Fence  
Using Wire Ladder;  
Test F1

As shown in figure 159, another climb over the top was made using a wire ladder. The ladder was thrown over the top of the fence and the inside end was attached to the fence fabric using a pair of carabiners. The time required to place the wire ladder and climb over was 0.46 minute. Vibrational disturbances as observed with a transducer approximately 15' away are shown in figure 160.

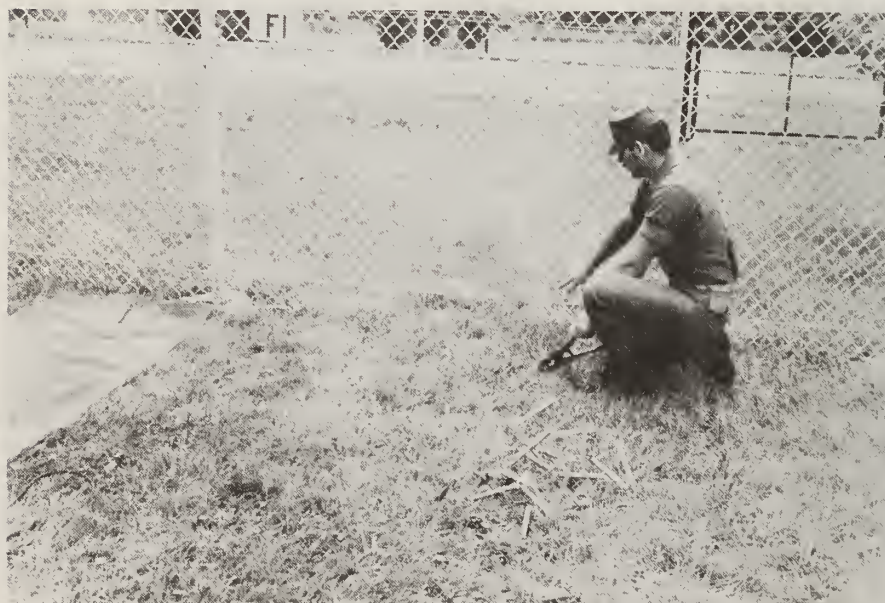
Figure 162. Opening Produced by  
Cutting 13 Wires with  
No. 14 Bolt Cutters; Test F1

Using the No. 14 bolt cutters, it took 0.32 minute to cut 13 wires and produce the opening shown in figure 162. With the transducer 10' from the attack point, the vibrational disturbances were as shown in figure 163.

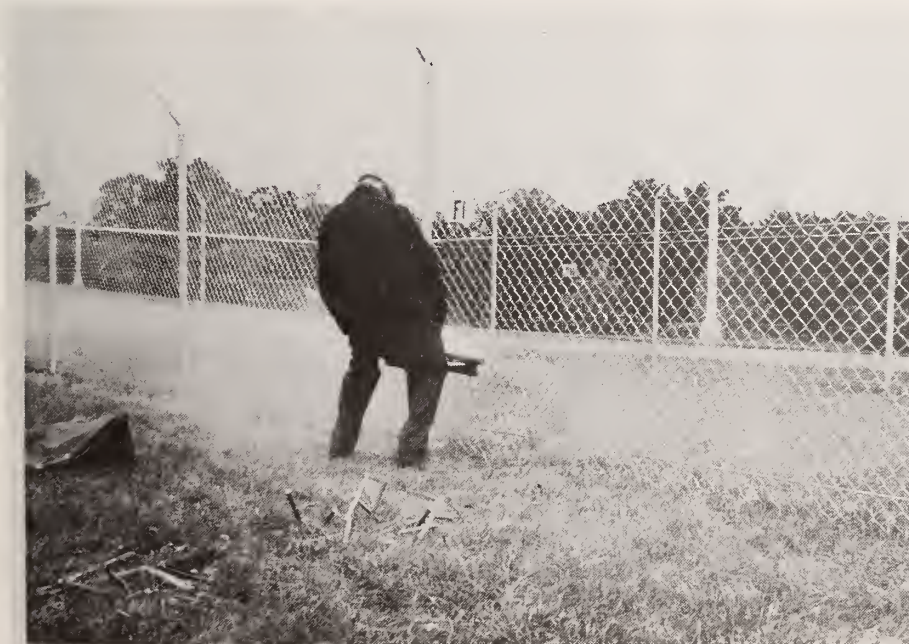
Figure 166. Abrasive Wheel Saw in Use; Test F1

The abrasive wheel saw was then used, as shown in figure 166, to make two cuts and form a triangular opening 17" wide and 15" high. This required 0.17 minute working time and 0.48 minute elapsed time and produced vibrational disturbances, as shown in figure 167. The transducer was approximately 12' from the attack location.

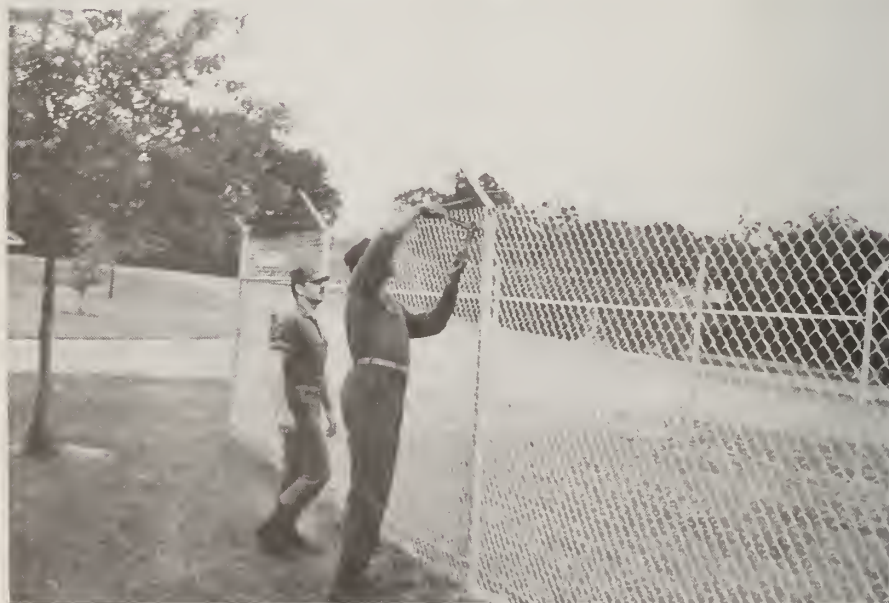
Figure 168. Cutting Wires which Attach Outriggers to Tops of Poles; Test F1

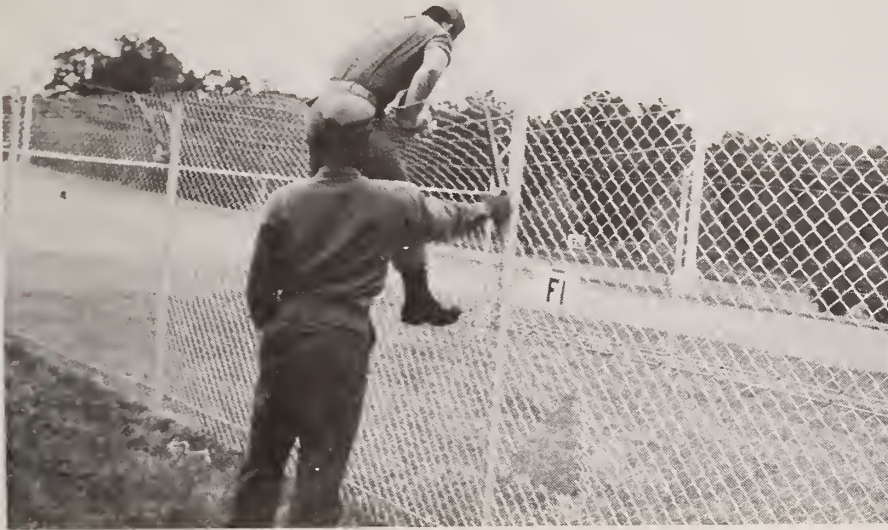
Figure 169. Outriggers, Still Attached to Barbed Wire, Cut, Pulled Down and Used as Hand and Foothold to Climb Over Fence; Test F1

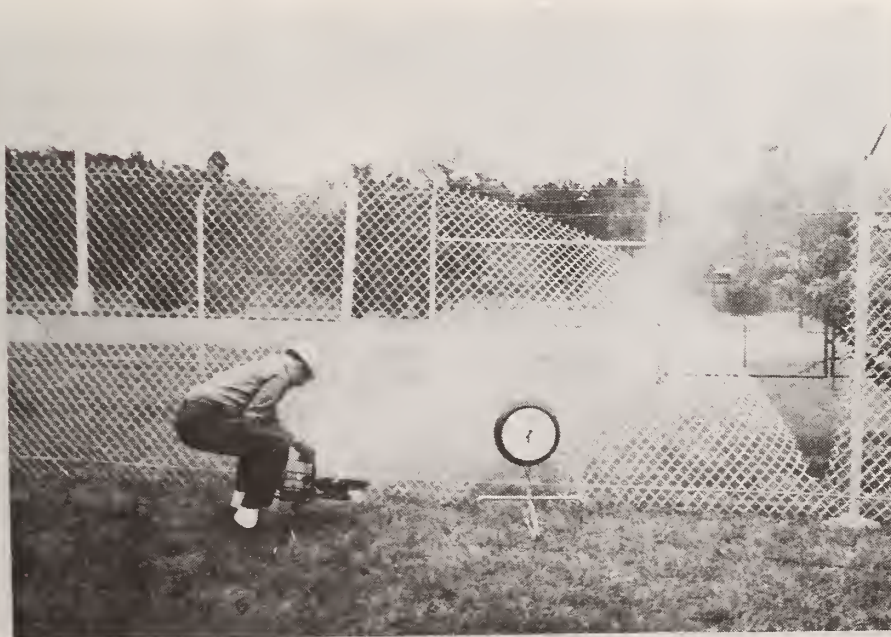
Figure 170. Abrasive Wheel Saw Used to Cut Nearly Full Height of Fabric and also to Cut Off One Intermediate Post; Test F1

Later, the abrasive wheel saw was used to make a cut for nearly the full height of the fabric in 0.26 minute and to cut off one of the intermediate posts in 0.34 minute, as shown in figure 170.

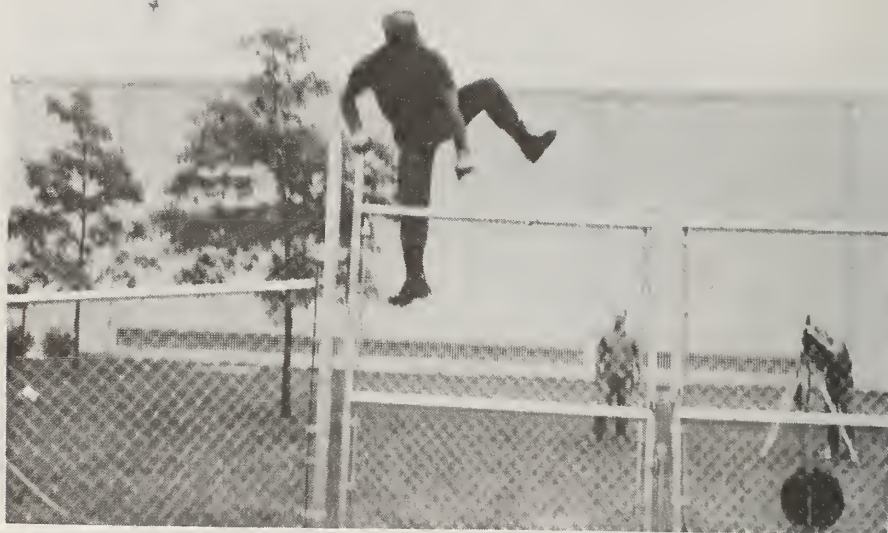
Figure 171. Gloved Hand Climb Over  
at Gate where Barbed Wire  
Outriggers Were Vertical;  
Test F1

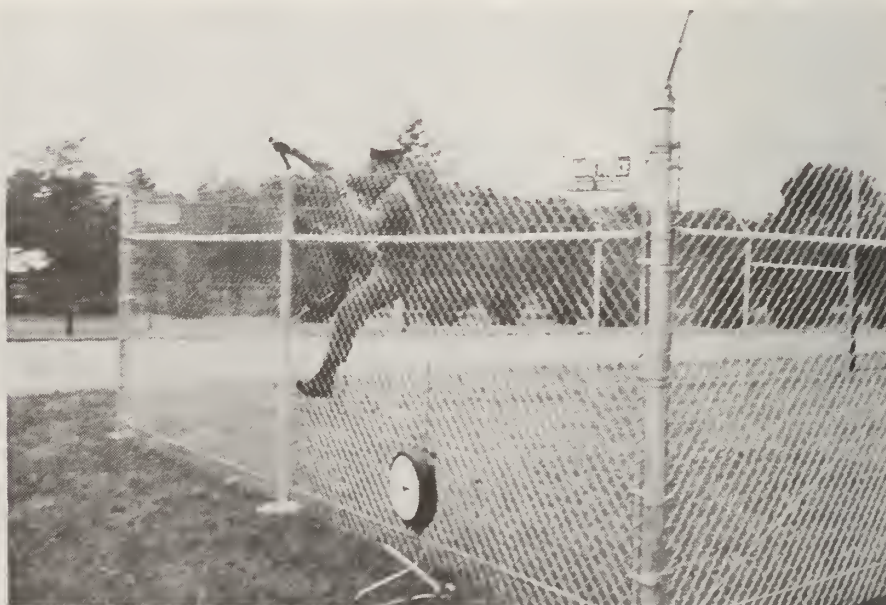
Figure 172. Gloved Hand Climb Over Started  
from Inside of Fence; Test F1

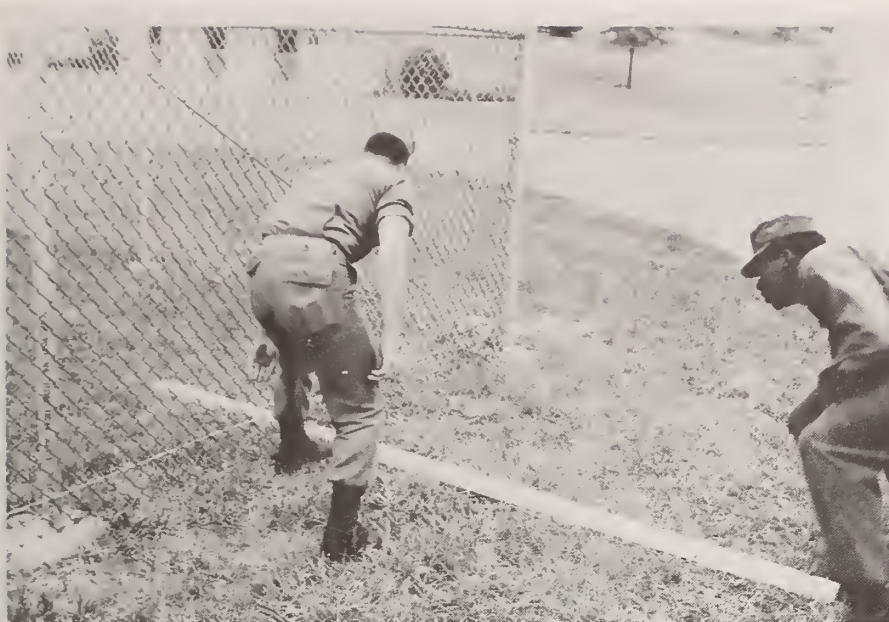
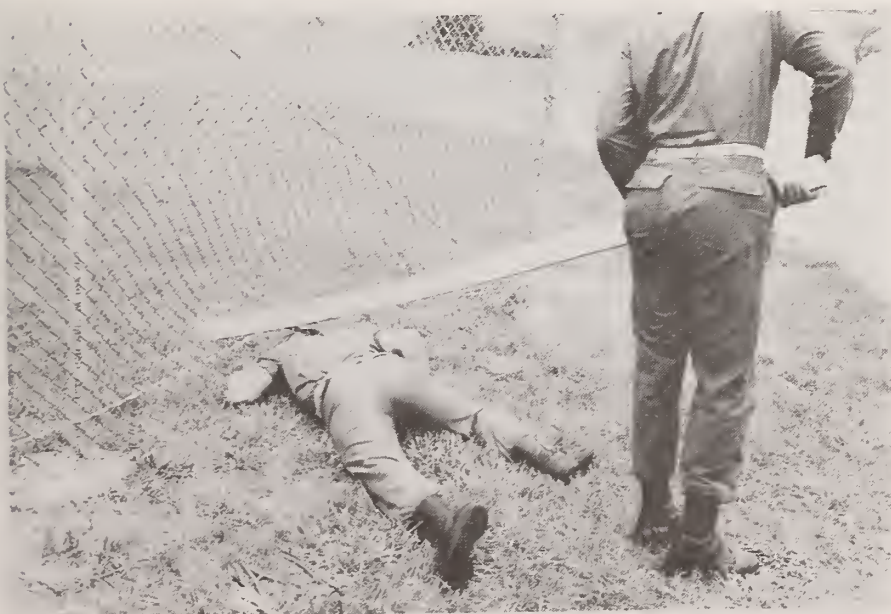
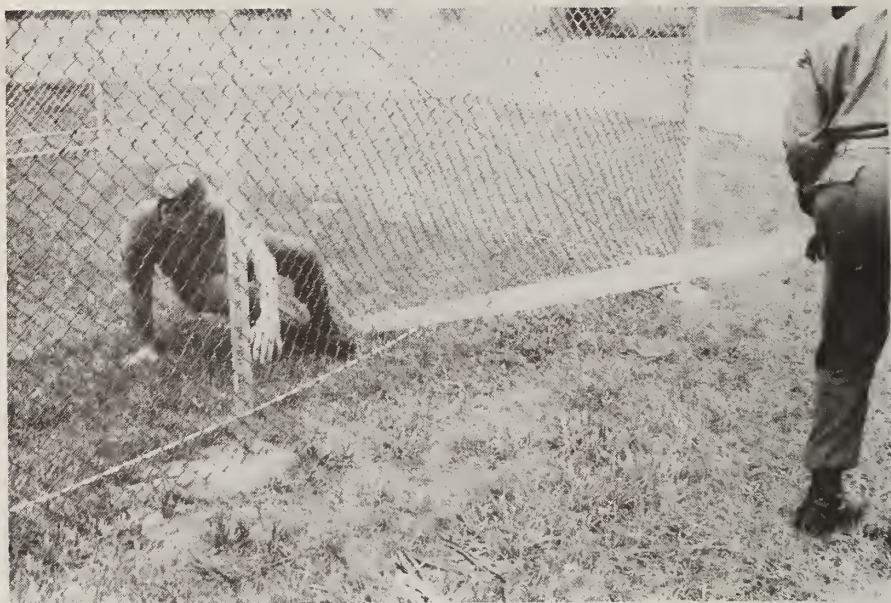
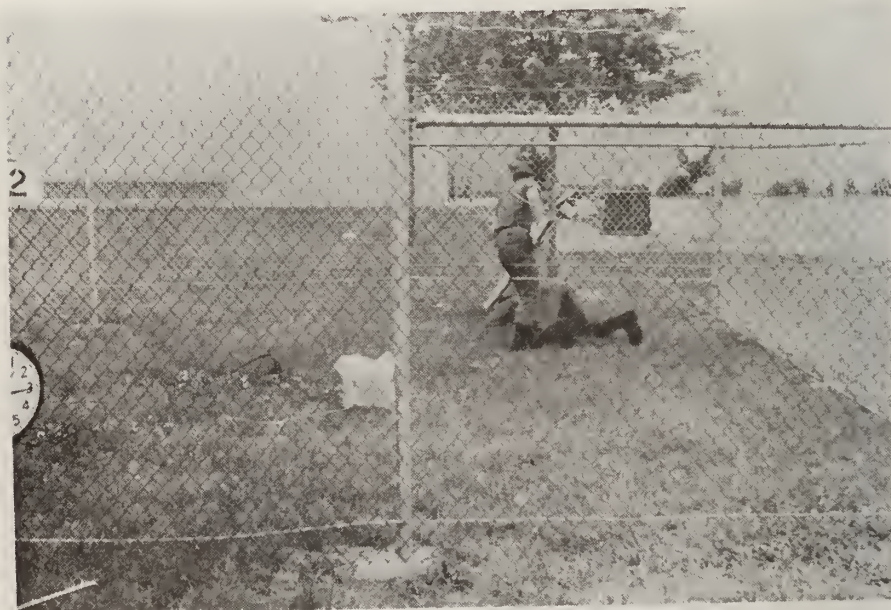
Figure 173. Placing 2 X 4 in Position;  
Test F2

Figure 174. First Man Crawling under F2;  
Test F2

Figure 175. First Man Inside the Enclosure;  
Test F2

Figure 176. Beginning to Crawl under F1;  
Test F2

Using the 2" X 4" timber, the bottom of the fence was lifted and a man crawled under in 0.14 minute. Then, a more dramatic test was set up. Two men started from a point 30' away from F2 and, using the 2" X 4" timber to lift the bottom of the fence, one crawled under and then pulled the 2" X 4" inside and lifted the fence for the second man. With both men inside the enclosure, they ran the 20' to F1 and repeated the process. Then they ran to a point 50' beyond F1. The total time for the two men to run 100' and crawl under the two fences was 0.95 minute. The sequence of events is shown in figures 173, 174, 175, 176, and 177.

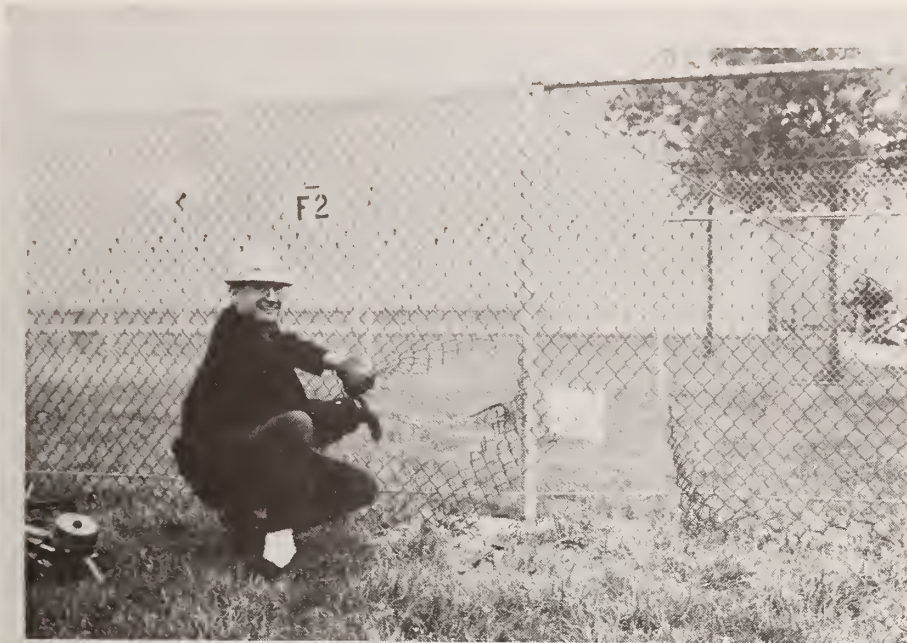
Figure 179. Opening Produced by  
Abrasive Wheel Saw; Test F2

The abrasive wheel saw was used to make a 21" long diagonal cut and a 22" horizontal cut and produce the opening shown in figure 179. in 0.44 minute. Multiple sweeps of the vibrational disturbances are shown in figure 180. These data were obtained with the transducer only two to three feet from the attack location.

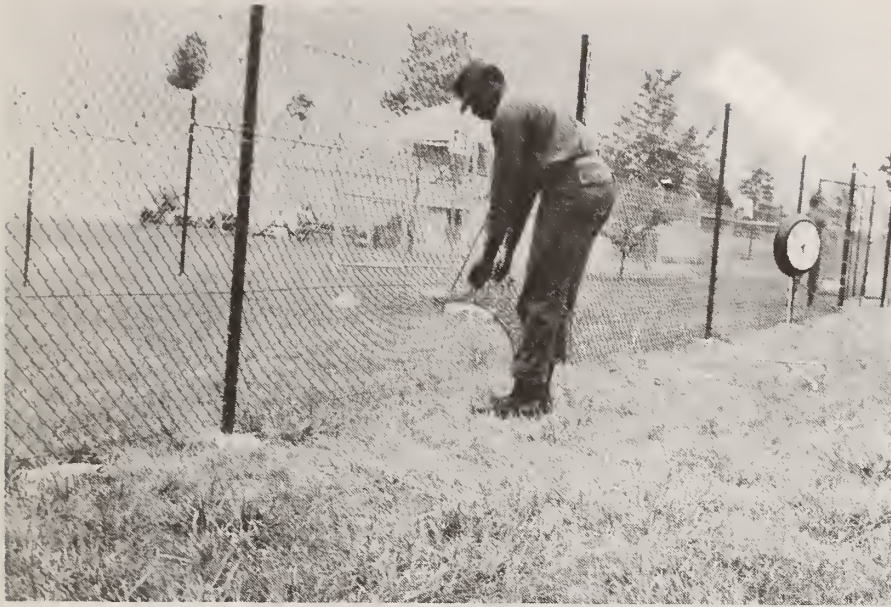
Figure 181. 25" High Opening Produced  
in Lighter Gauge Material;  
Test F3

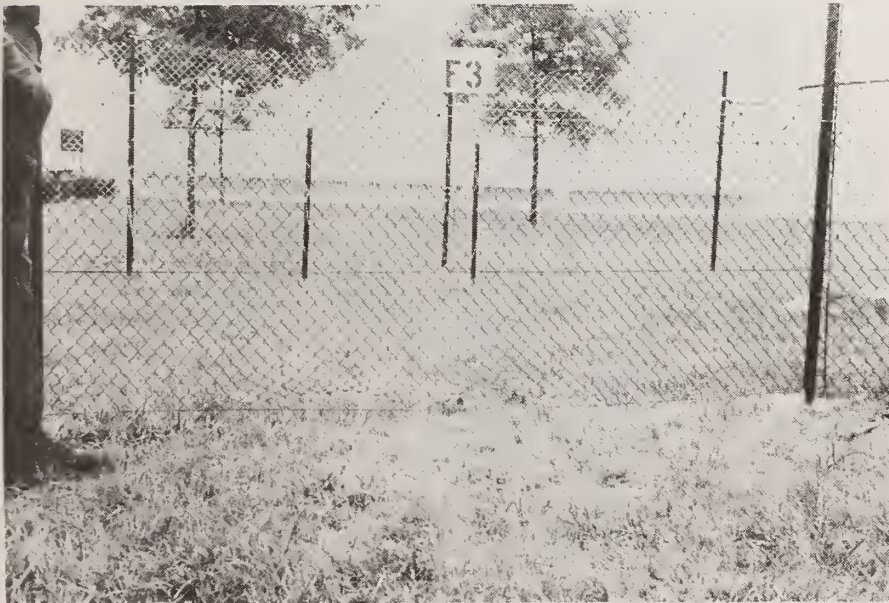
Figure 182. Appearance of Fabric after Dropping ;  
Test F3
